**Flood Control Project Maintenance  
Levee Inspections**

## Maintenance Issue Types Only, Levee Inspection Report By Mile - Spring 2017

### Reclamation District No. 0307 Lisbon

Waterway	Bank	Unit Miles	Inspection Start/End	Inspector
Unit No. 01 Sacramento River	Right	6.56	04/13/2017 04/13/2017	Herman Phillips

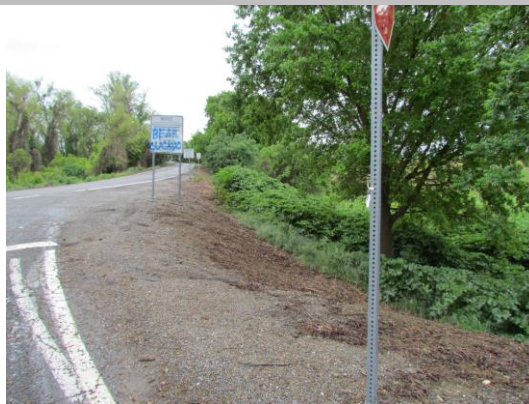
Photo 1 of 1 : SP\_2017\_RD0307\_166\_53\_20170519\_00107.jpg

LM Start	0.00	Rating **	U	Issue No.	53
LM End	0.24	Issue Type +	Ma	Location *	LS
Category	Earthen Levee			GPS Latitude/Longitude	
				Start	End
Item	Vegetation			38.480043 °	38.477615 °
				-121.549543 °	-121.546408 °
DWR ID	DWR_RD0307_01_s_2017_53				
Comment Code					
V1 : Control annual grass and weeds on the levee slopes and easements.					
Inspector Comment					
Control the annual grasses other than native from the slope and berm.

RD 307 looking downstream from levee mile 0.00 landside slope.

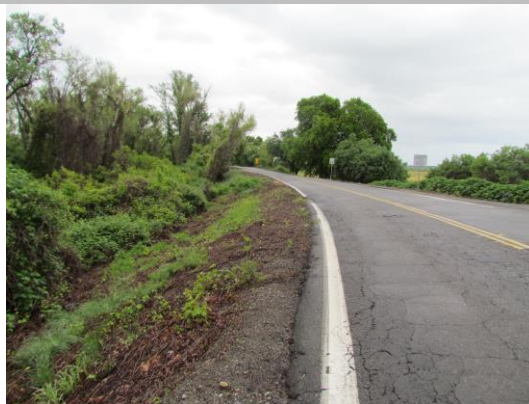
Photo 1 of 1 : SP\_2017\_RD0307\_166\_54\_20170519\_00108.jpg

LM Start	0.01	Rating **	U	Issue No.	54
LM End	6.41	Issue Type +	Ma	Location *	WS
Category	Earthen Levee			GPS Latitude/Longitude	
				Start	End
Item	Vegetation			38.479968 °	38.431917 °
				-121.549452 °	-121.533327 °
DWR ID	DWR_RD0307_01_s_2017_54				
Comment Code					
V1 : Control annual grass and weeds on the levee slopes and easements.					
Inspector Comment					
The RD SCHEDULE FOR LEVEE MAINTENANCE DURING THE LATE SPRING.

RD 307 Looking downstream from the waterside levee mile 0.01.

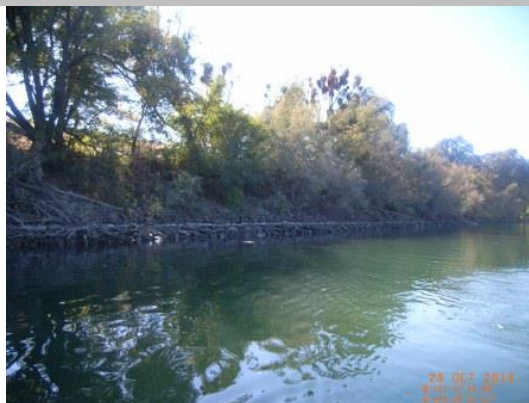
Photo 1 of 1 : SP\_2017\_RD0307\_166\_1\_20170404\_00001.jpg

LM Start	1.17	Rating **	M	Issue No.	1
LM End	1.31	Issue Type +	Ma	Location *	WS
Category	Supplemental			GPS Latitude/Longitude	
				Start	End
Item	2015 USACE Erosion Survey, DRAFT			38.473059 °	38.473082 °
				-121.530988 °	-121.528437 °
DWR ID	DWR_RD0307_01_s_2016_1				
Comment Code					
Inspector Comment					
2012 - Bank is slowly eroding, old rock protection starting to unravel. 2015: No observed changes. [2015 Site ID: SAC_48-6_R]

USACE 2013 Photo #1

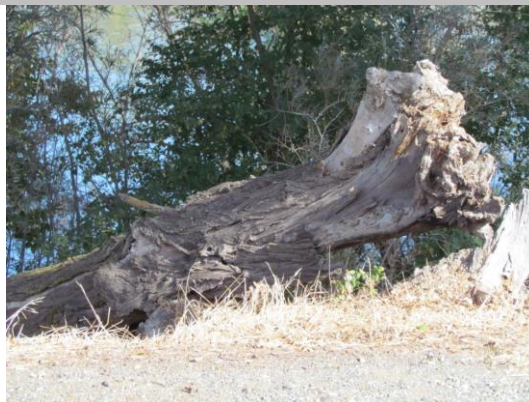
Photo 1 of 1 : SP\_2017\_RD0307\_166\_9\_20170404\_00006.jpg

LM Start	1.29	Rating **	U	Issue No.	9
LM End	1.29	Issue Type +	Ma	Location *	WS
Category	Earthen Levee			GPS Latitude/Longitude	
				Start	End
Item	Encroachments			38.472827 °	38.472827 °
				-121.528785 °	-121.528785 °
DWR ID	DWR_RD0307_01_f_2014_9				
Comment Code					
TR : Tree or limb					
Inspector Comment					
I have instructed the RD to schedule with his contractor to cut this tree up and have it removed from the levee section.

This tree needs to be removed from the waterside slope. No change 4-17.

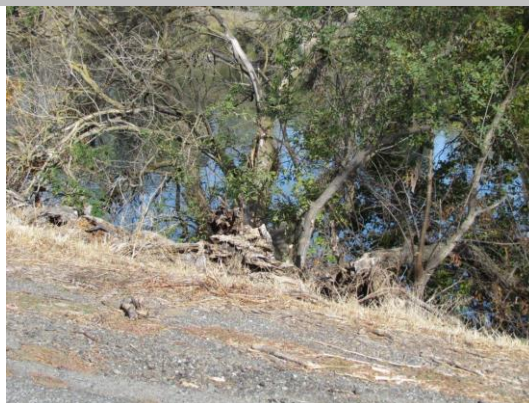
Photo 1 of 1 : SP\_2017\_RD0307\_166\_10\_20170404\_00007.jpg

LM Start	1.35	Rating **	M	Issue No.	10
LM End	1.35	Issue Type +	Ma	Location *	WS
Category	Earthen Levee			GPS Latitude/Longitude	
				Start	End
Item	Encroachments			38.472880 °	38.472880 °
				-121.527733 °	-121.527733 °
DWR ID	DWR_RD0307_01_f_2014_10				
Comment Code					
TR : Tree or limb					
Inspector Comment					
The RD will schedule to have these trees cut up and removed from the waterside levee section as soon as possible.

Remove unwanted trees from waterside slope. These trees are dead and are resting on the slope. No change 4-17.

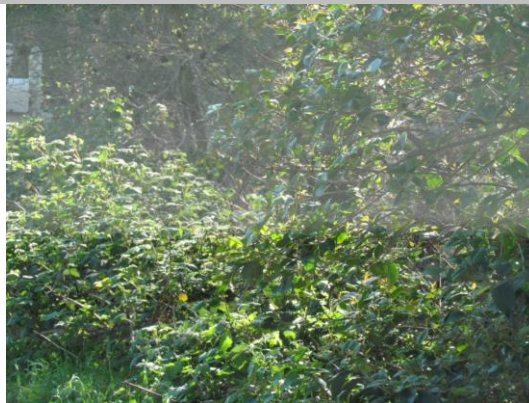
Photo 1 of 1 : SP\_2017\_RD0307\_166\_69\_20170404\_00019.jpg

LM Start	1.59	Rating **	U	Issue No.	69
LM End	1.66	Issue Type +	Ma	Location *	LS
Category	Earthen Levee			GPS Latitude/Longitude	
				Start	End
Item	Vegetation			38.473190 °	38.473240 °
				-121.523260 °	-121.521942 °
DWR ID	DWR_RD0307_01_s _ 2016_69				
Comment Code					
V2 : Remove the wild growth other than native grasses from the levee slopes.					
Inspector Comment					
Spray the berry vines present at this location. No change 4-17.

Looking downstream from levee miles 1.59-1.66 slope covered in berry vines.

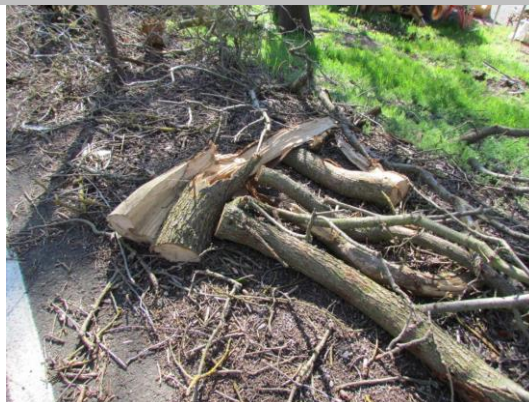
Photo 1 of 3 : SP\_2017\_RD0307\_166\_73\_20170404\_00020.jpg

LM Start	1.86	Rating **	U	Issue No.	73
LM End	1.87	Issue Type +	Ma	Location *	LS
Category	Earthen Levee			GPS Latitude/Longitude	
				Start	End
Item	Encroachments			38.473182 °	38.473243 °
				-121.518280 °	-121.518078 °
DWR ID	DWR_RD0307_01_s_2016_73				
Comment Code					
TR : Tree or limb					
Inspector Comment					
Remove the cut up oak tree from the levee section waterside and landside. No change 4-17.

Looking downstream from levee mile 1.86 cut up fallen tree on shoulder.

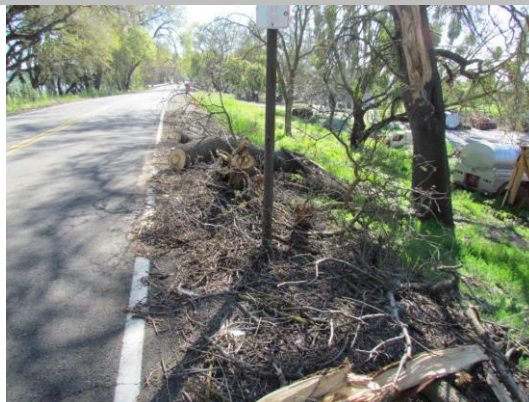
Photo 2 of 3 : SP\_2017\_RD0307\_166\_73\_20170404\_00021.jpg

Looking downstream toward levee mile 1.87 fallen tree on shoulder.

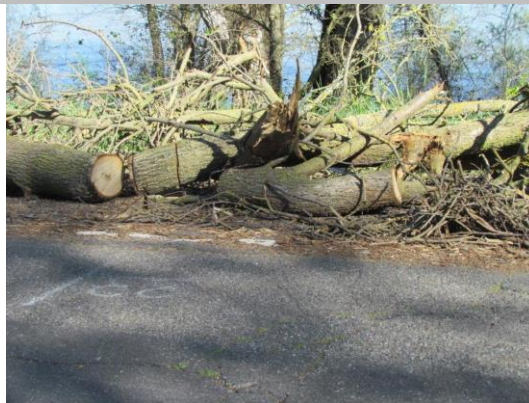
Photo 3 of 3 : SP\_2017\_RD0307\_166\_73\_20170404\_00022.jpg

LM Start	1.86	Rating **	U	Issue No.	73 (cont)	
LM End	1.87	Issue Type +	Ma	Location *	LS	
Category	Earthen Levee			GPS Latitude/Longitude		
				Start	End	
Item	Encroachments			38.473182 °	38.473243 °	
				-121.518280 °	-121.518078 °	
DWR ID	DWR_RD0307_01_s_2016_73					
Comment Code						
TR : Tree or limb						
Inspector Comment						
Remove the cut up oak tree from the levee section waterside and landside. No change 4-17.

Waterside shoulder levee mile 1.86 more of the cut up oak.

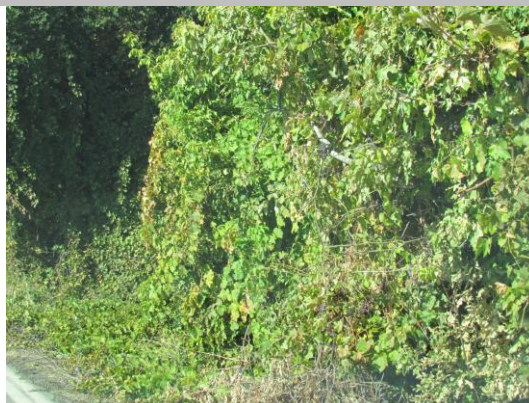
Photo 1 of 1 : SP\_2017\_RD0307\_166\_66\_20170404\_00018.jpg

LM Start	5.39	Rating **	U	Issue No.	66
LM End	5.49	Issue Type +	Ma	Location *	LS
Category	Earthen Levee			GPS Latitude/Longitude	
				Start	End
Item	Vegetation			38.435602 °	38.435653 °
				-121.517151 °	-121.519035 °
DWR ID	DWR_RD0307_01_f_2016_66				
Comment Code					
V1 : Control annual grass and weeds on the levee slopes and easements.					
Inspector Comment					
Control the wild grapes from the landside levee slope and shoulder. No change.

RD 307 levee mile 5.39-5.49 landside shoulder and slope. Nochange.

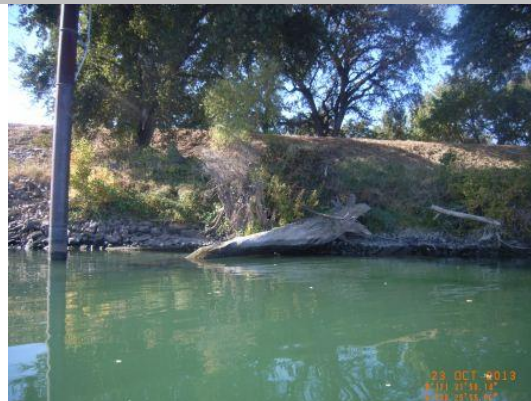
Photo 1 of 1 : SP\_2017\_RD0307\_166\_2\_20170404\_00002.jpg

LM Start	6.19	Rating **	M	Issue No.	2
LM End	6.38	Issue Type +	Ma	Location *	WS
Category	Supplemental			GPS Latitude/Longitude	
				Start	End
Item	2015 USACE Erosion Survey, DRAFT			38.434560 °	38.432287 °
				-121.531159 °	-121.532978 °
DWR ID	DWR_RD0307_01_s_2016_2				
Comment Code					
Inspector Comment					
2008 - Large rotational failure in bank and well into the levee slope. Could be a significant problem in the next high flow event. 2009 - Minimal new erosion, site extended upstream. 2010 - Minor new erosion. 2011 - Tree popout has left a large hole. Large slump area. Rock on the bank is failing in some locations. 2012 - The toe appears to be scouring out. 2015: No observed changes. [2015 Site ID: SAC_43-2_R]

USACE 2013 Photo #1

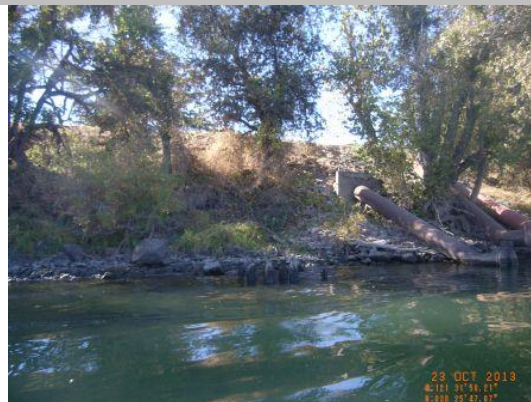
Photo 1 of 1 : SP\_2017\_RD0307\_166\_8\_20170404\_00005.jpg

LM Start	6.42	Rating **	M	Issue No.	8
LM End	6.55	Issue Type +	Ma	Location *	WS
Category	Supplemental			GPS Latitude/Longitude	
				Start	End
Item	2015 USACE Erosion Survey, DRAFT			38.431726 °	38.429957 °
				-121.533200 °	-121.533035 °
DWR ID	DWR_RD0307_01_s_2016_8				
Comment Code					
Inspector Comment					
2011 - Erosion pockets likely from tree popouts. This site has been in the inventory before and been fixed with emergency bank rock but continues to fail. 2015: No observed changes. [2015 Site ID: SAC_43-1_R]

USACE 2013 Photo #1

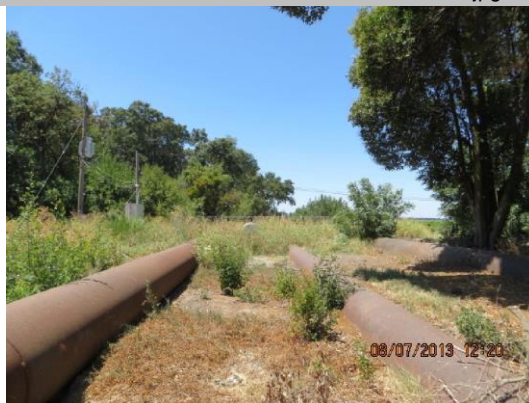
Photo 1 of 3 : UCIP\_SP\_2017\_17406\_29510.jpg

LM Start	6.54	Rating **	A/W	Issue No.	122
LM End	6.54	Issue Type +	Ma	Location *	WS
Category	Supplemental			GPS Latitude/Longitude	
				Start	End
Item	DWR UCIP LMA Responsibility			38.430043 °	38.430043 °
				-121.533275 °	-121.533275 °
DWR ID					
Comment Code					
Inspector Comment					
FS_ID:17406					
DS_ID:21731					
EP_NO: N/A					
Repair Type: No Action Needed					
Crossing Status: Found					
UCIP Comments:					
FIELD_STRUCT_DESC: 2 of 2: 36-inch steel drain pipe through the levee 16.0 feet below the crown. Flap gate on the waterward end, gate valve and air vent on the landward side. Pump and trash rack 200-feet off LS toe. Originally included in the 1959 O&M manual.					
FS Date: 8/7/2013

Pipes visible on LS toe.

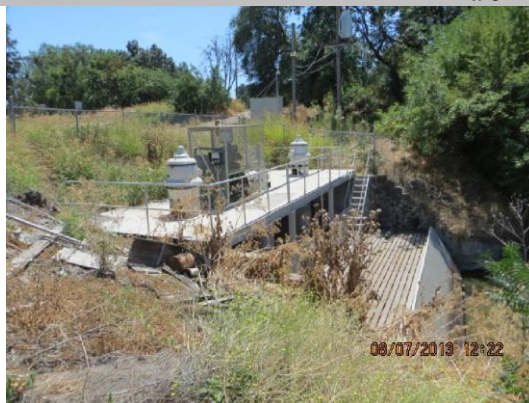
Photo 2 of 3 : UCIP\_SP\_2017\_17406\_29509.jpg

Pump and trash rack 200-feet off LS toe.

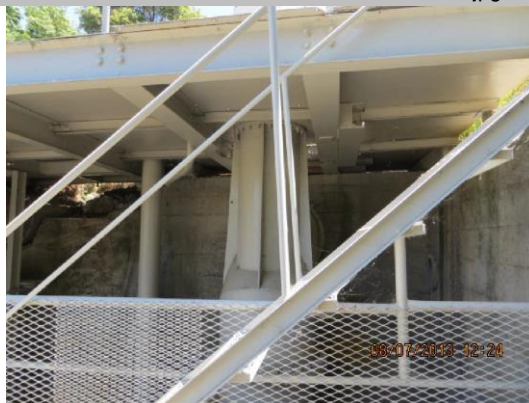
Photo 3 of 3 : UCIP\_SP\_2017\_17406\_29508.jpg

LM Start	6.54	Rating **	A/W	Issue No.	122 (cont)	
LM End	6.54	Issue Type +	Ma	Location *	WS	
Category	Supplemental			GPS Latitude/Longitude		
				Start	End	
Item	DWR UCIP LMA Responsibility			38.430043 °	38.430043 °	
				-121.533275 °	-121.533275 °	
DWR ID						
Comment Code						
Inspector Comment						
FS_ID:17406						
DS_ID:21731						
EP_NO: N/A						
Repair Type: No Action Needed						
Crossing Status: Found						
UCIP Comments:						
FIELD_STRUCT_DESC: 2 of 2: 36-inch steel drain pipe through the levee 16.0 feet below the crown. Flap gate on the waterward end, gate valve and air vent on the landward side. Pump and trash rack 200-feet off LS toe. Originally included in the 1959 O&M manual.						
FS Date: 8/7/2013

Intake at concrete headwall under pump.
